Manhole Inspection Summary

Manhole # S45M__006MH

Insp Date: **6/6/08 9:25 AM**

Location Address: **1800 ann st**

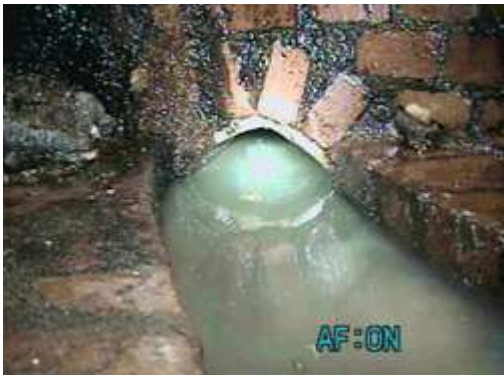
Defect 2

Infiltration: ☐ None ☐ Joint ☐ Cracks ☐ Mortar ☐ Roots ☒ **Wall**

Barrel Infiltration

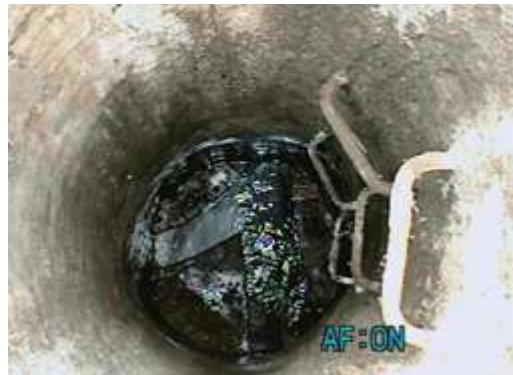
Defect 1

Infiltration: ☐ None ☐ Joint ☐ Cracks ☐ Mortar ☐ Roots ☒ **Wall**

☒ **Corroded**

Corroded Steps, Corbel Infiltration

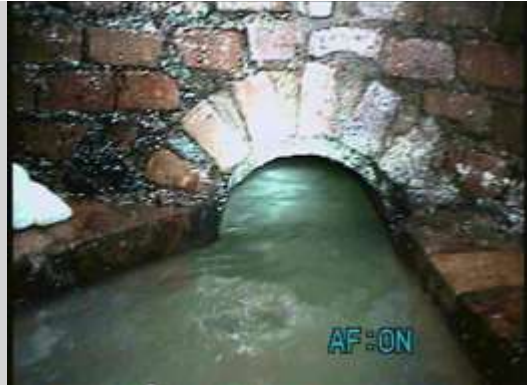
12 O'Clock Outflow

10 in. Circular Gravity Sewer
Pipe Out @ 12 O'Clock

Infiltration: **None** Pipe Seal Cond: **Unknown**

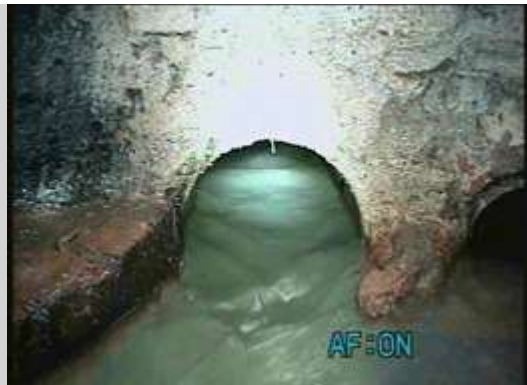
5 O'Clock Inflow

10 in. Circular Gravity Sewer
Pipe In @ 5 O'Clock

Infiltration: **None** Pipe Seal Cond: **Unknown**

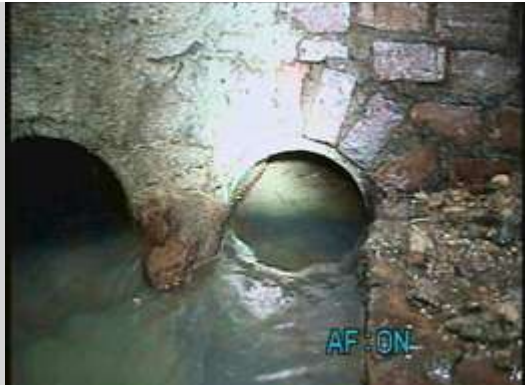
6 O'Clock Inflow

Infiltration: **None**

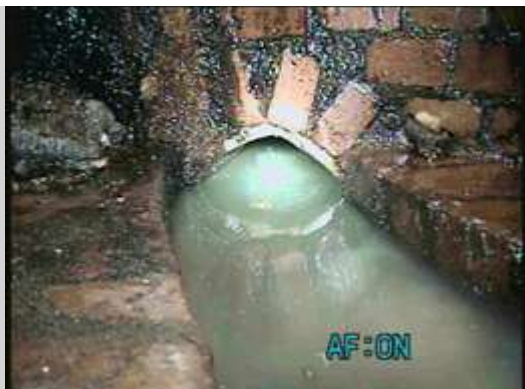
9 O'Clock Inflow

Infiltration: **None**
